## Asbestos bags recycled for use in carpet underlay

### Background

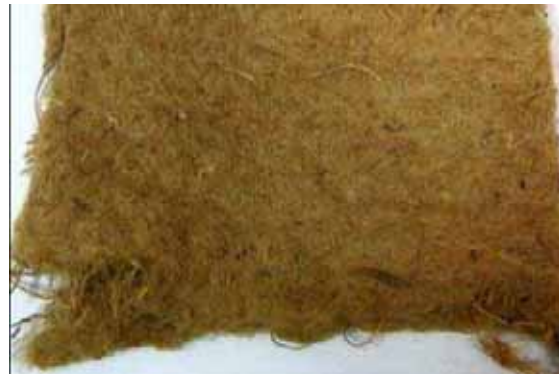
The exact characteristics of the suspect underlay are not fully known. However, it is likely to be brown in colour and look like a fibrous mat (see right). It is also likely to be compacted as it has been under the carpet and walked on. In most cases, the underlay was either glued on to a concrete floor or stapled on to a timber floor.

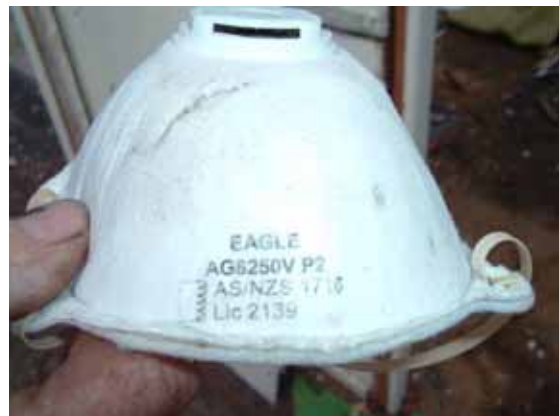
You can safely inspect your carpet for the suspect underlay. You should wear a "Class P2" face mask (not a dust mask) at all times when undertaking this task (see right). Single-use P2 masks are available from safety equipment stores and some hardware stores. They will state "P2" and "AS/NZS 1716" on the mask.
