# Is it safe? Cracked, damaged or weathered asbestos cement sheeting

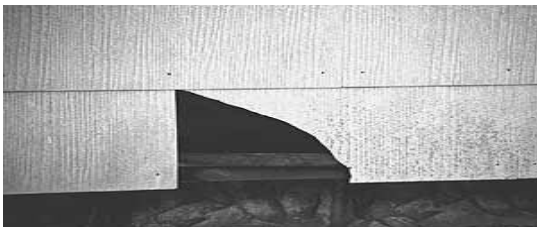
## Cracked or Damaged Sheeting

At the time asbestos cement sheeting is cracked or damaged, some respirable asbestos fibres can be released into the air.

However, the number of released fibres is likely to be very low. This is because the material is not 100% asbestos, asbestos fibres in the sheeting are predominantly large and the asbestos is bound into the cement.

If you are close to the material when it cracks or is damaged, it poses a very low health risk. The health risk reduces if you are further away.

After it is damaged, asbestos cement sheeting does not continue to release significant asbestos fibres into the air. This is because the asbestos continues to be bound in the cement. To protect exposed edges from ongoing damage or fibre release, they can be painted or sealed.

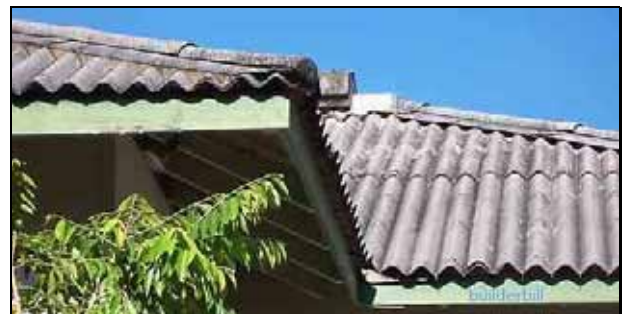
## Weathered Roofs

Over time, asbestos cement roofs will deteriorate. The cement slowly breaks down and asbestos fibres are washed and blown away.

Even if an asbestos cement roof is in poor condition, it is not likely to pose an increased risk to your health. Any released fibres rapidly disperse into the air and their concentration (the number of fibres in an amount of air) reduces within a short distance from the roof.

Air testing near the ground has shown the concentration of fibres is very low<sup>1</sup> – the same as if the asbestos cement roof was not there.

Asbestos cement roofs can be left in place until they are no longer water tight. However, they can pose an increased risk to your health when they are disturbed or being worked on, especially with power tools or water blasters, or when the roof gutters are being cleaned. Precautions need to be taken at such times.
