Abbot Point Bulk Coal Pty Ltd (Adani) Investigation – Breach of TEL conditions.

Preliminary assessment of impacts to Caley Valley Wetlands from Abbot Point Coal Terminal post Tropical Cyclone Debbie.

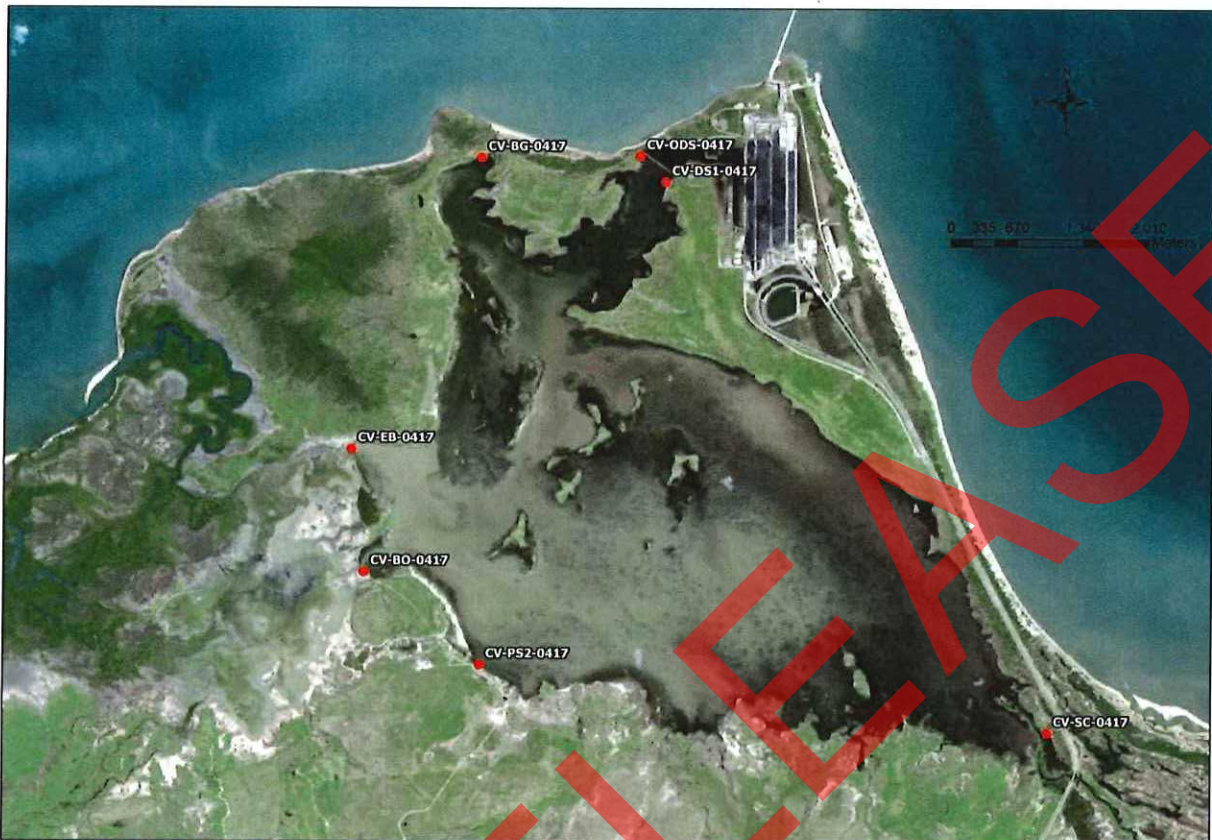
Figure 2: Copernicus Sentinel-2 satellite image (11 April 2017) of Caley Valley wetland and sediment sampling locations. The image is displayed as a true colour composite with bands 4, 3 and 2 assigned respectively to the red, green and blue colours. The satellite image was used to help identify sampling locations.

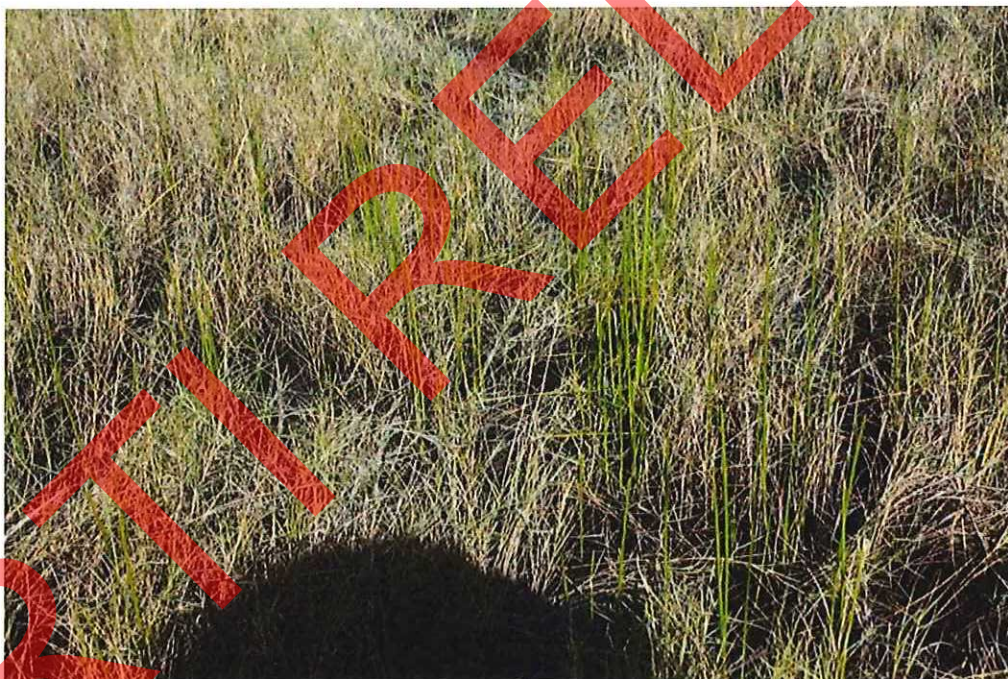
The impacts at this site included what appeared to be partial coverage of the wetland substrate with coal fines and coal residue, and partially discolouring of the lower stems of the marine couch (*Sporobolus virginicus*). This is consistent with the sediment analysis at this site.

Although there was evidence of discolouration and what appeared to be coal residues, there did not appear to be any impediment to growth of wetland plants such as mangrove clubrush (*Schoenoplectus littoralis*), which is responding (i.e. emerging as new growth) to the recent flooding (Figure 4).

Figure 4: Mangrove clubrush (*Schoenoplectus littoralis*) is the bright green emerging reed in this photo at site CV-DS1-0417.

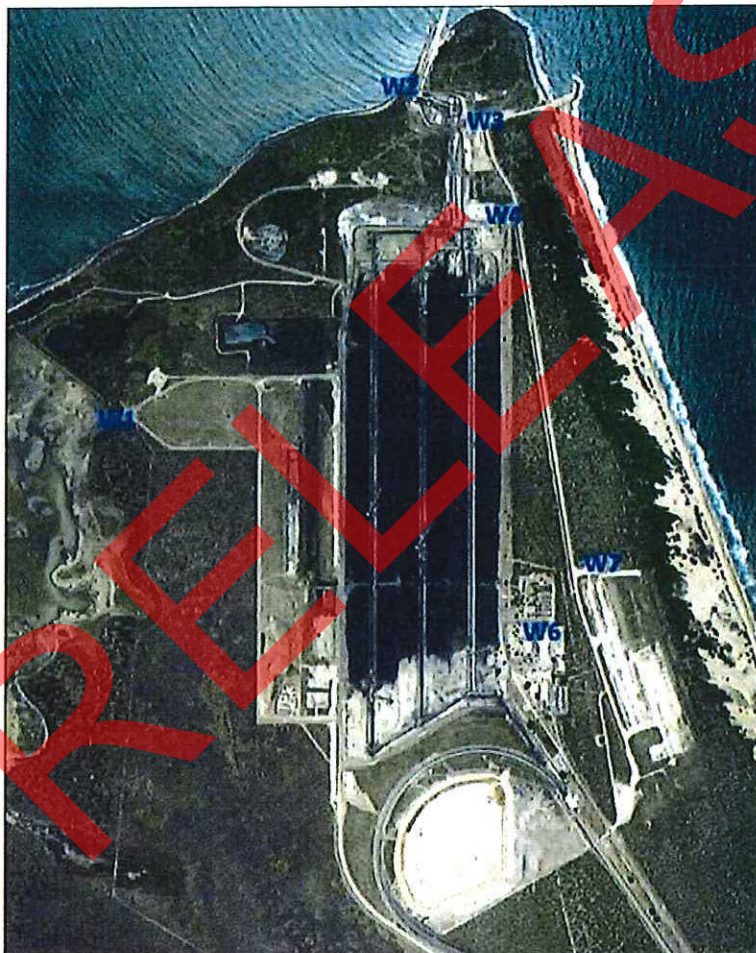
W1	Discharge Point from the Secondary Settlement Pond
W2	Sample Plant Water Drain
W3	Land adjacent to the Surge Bin sediment sump
W4	Land adjacent to the Main Sub Station sediment sump
W6	Outflow from the oil/water separator from motor vehicle workshop
W7	Outflow from the final holding tank of the sewage treatment plant

Figure 1: Contaminant Release Point – W1 and W2 for this TEL.

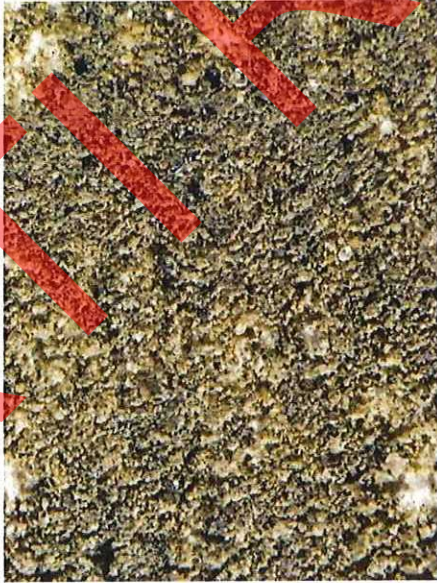
StMPM1. , CV-DSI-0417, UQMP # 14907. Very small dark brown to gold coloured particles with a number of black angular particulates, typical of coal noted and dispersed throughout the deposit.

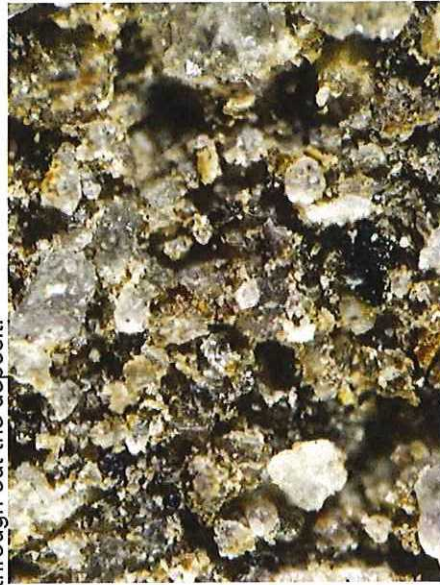
StMPM3. CV-ODS-0417, UQMP # 14909. Coarse grained particles with a range of colours from white to brown with a few black angular particles in the field of view.

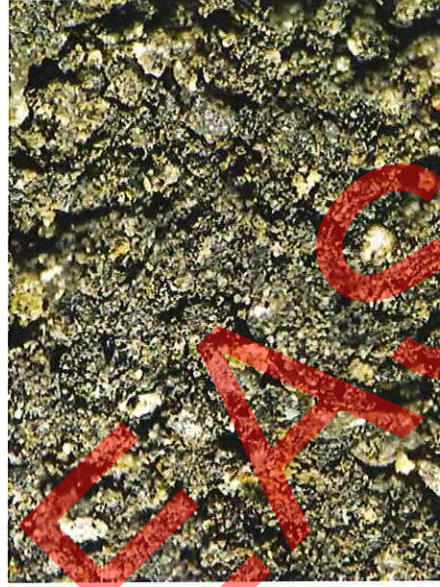
StMPM4. CV-S2-0417, UQMP # 14910. A few coarse particles with very fine particles dispersed throughout the deposit predominantly light brown with some gold coloured and translucent particles.

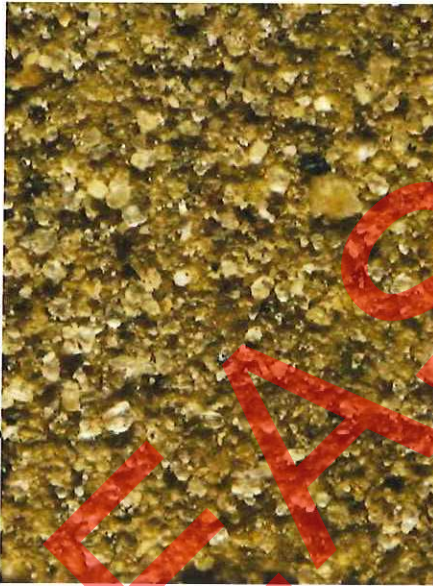
StMPM8. CV-PS2-0417, UQMP # 14914. Coarse grained particles mostly light brown to gold with a few translucent particles throughout the deposit.

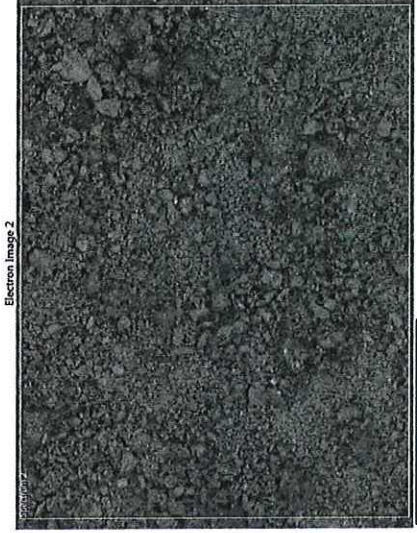
PM2. CV-DSI-0417, UQMP # 14907. An SEM/BSE image of a characteristic overall area selected for SEM/EDS analysis. (100 x Magnification)

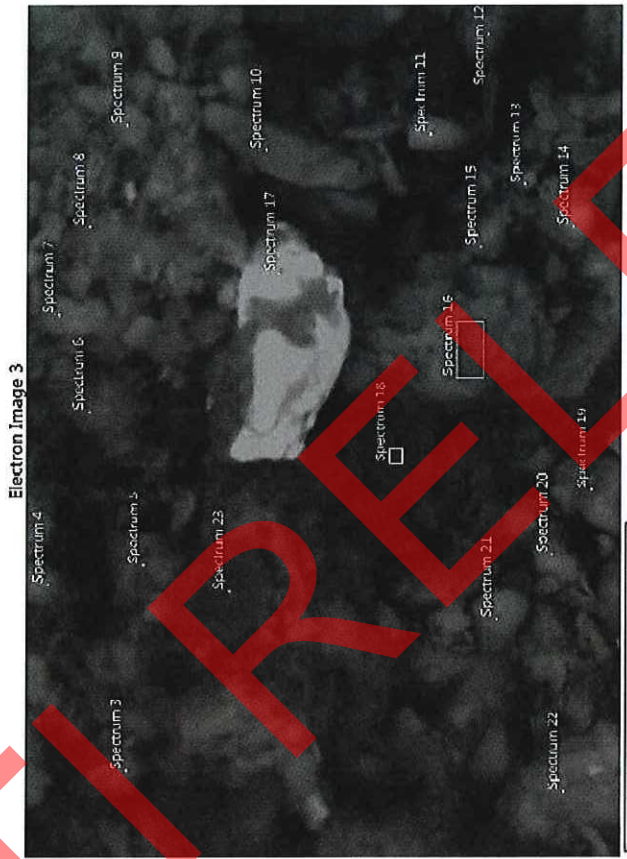
PM3. CV-DSI-0417, UQMP # 14907. An SEM/BSE image of a particles selected for SEM/EDS analysis.

CV-DSI-0417 (Sludge Overall), UQMP # 14907. A summary table of particles selected above for SEM/EDS analysis. A high ash coal particle was detected with most of the particles consisting of a grain size of < 2 µm. Clay minerals typically are aluminium silicates containing cations, alkalis and alkaline earth metals as essential components. Magnesium and iron often substitute in the matrix for aluminium. There small size creates a large surface area to volume ratio and reactive surface area with high cation exchange capacities. Some clays can increase their volume by 50 % with water absorption, which can create instability in soils.

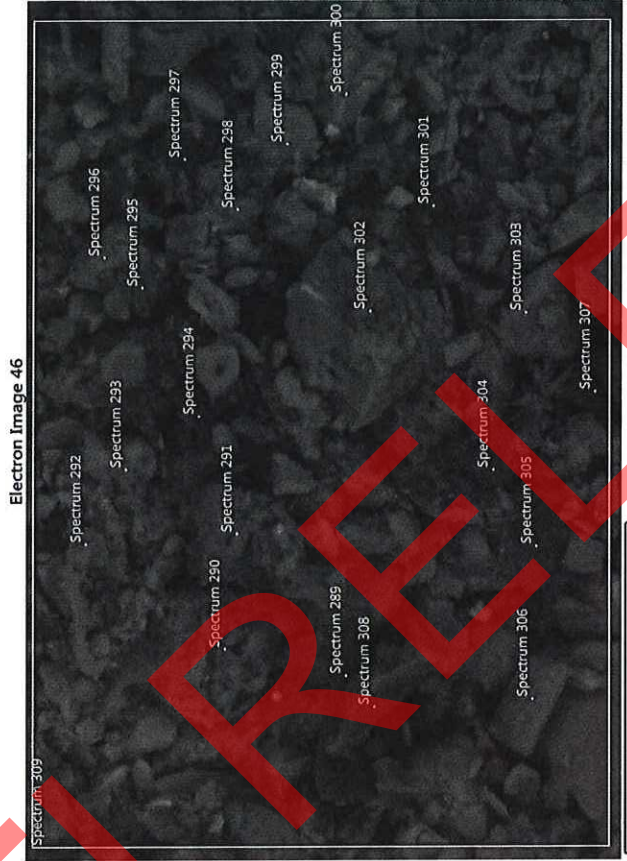
PM6. CV-DSI-0417, UQMP # 14907. An SEM/BSE image of a particles selected for SEM/EDS analysis.
