Analysis Methods

Abbot Point Bulk Coal Pty Ltd (Adani) Investigation – Breach of TEL conditions.

Preliminary assessment of impacts to Caley Valley Wetlands from Abbot Point Coal Terminal post Tropical Cyclone Debbie.

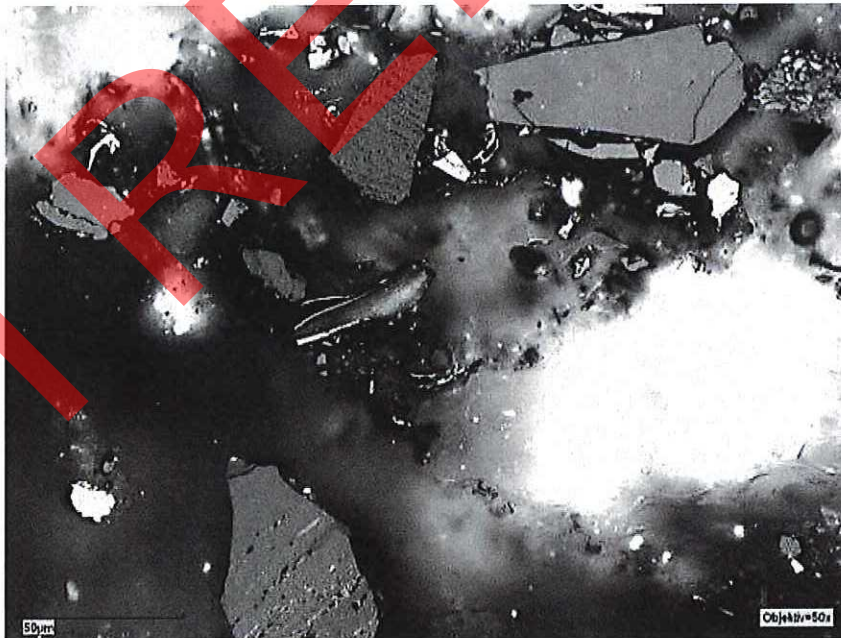
Figure 2: A cluster of Vitrinite grains and some interspersed minerals; 50x objective, oil immersion, reflected white light.

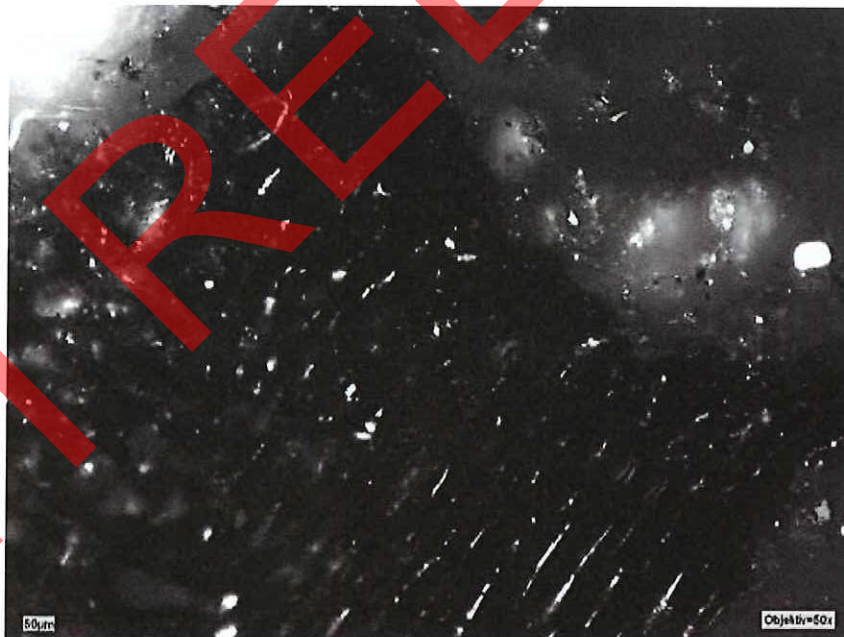
Figure 4: Organic Matter; 50x objective, oil immersion, reflected white light.

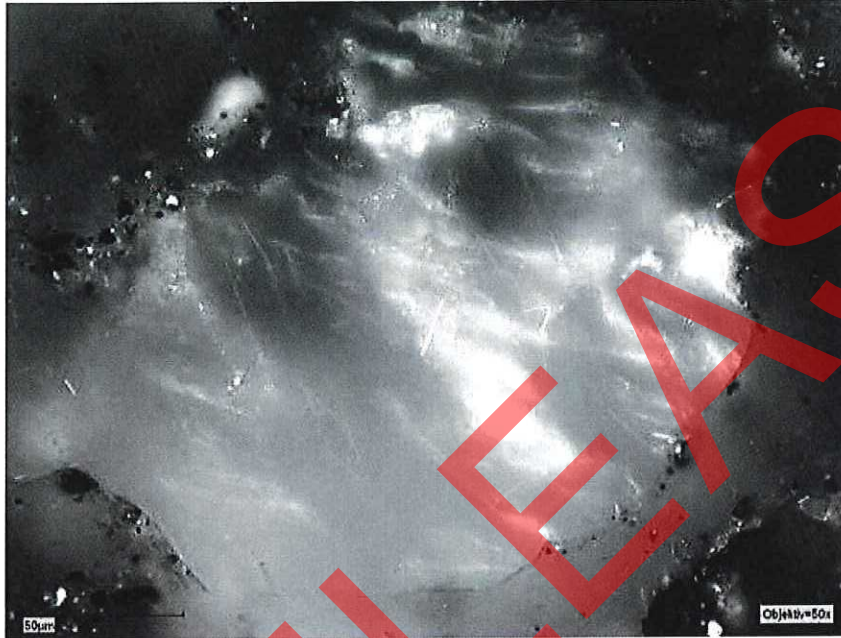
Figure 5: Mineral Matter; 50x objective; oil immersion, reflected white light.

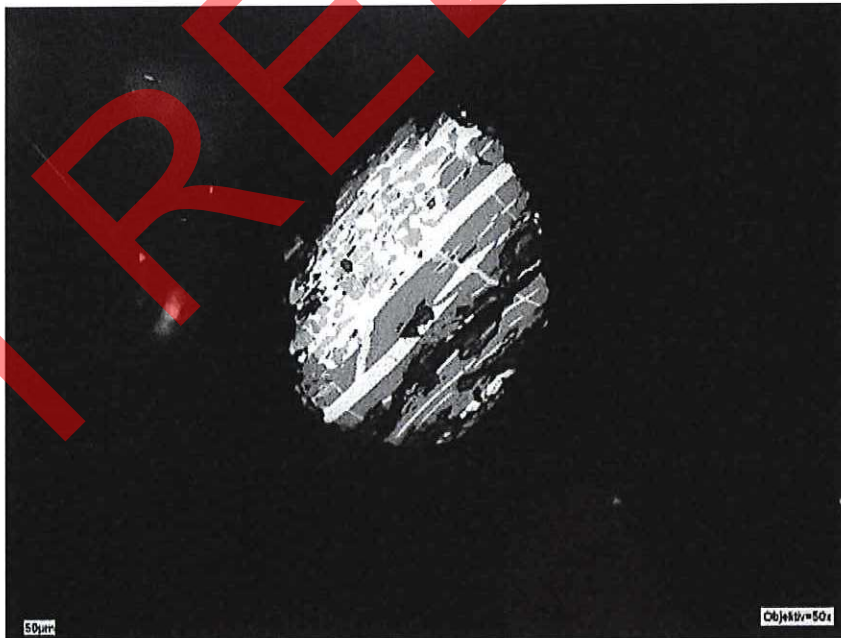
Figure 6: Mineral Matter; 50x objective, oil immersion, reflected white light.

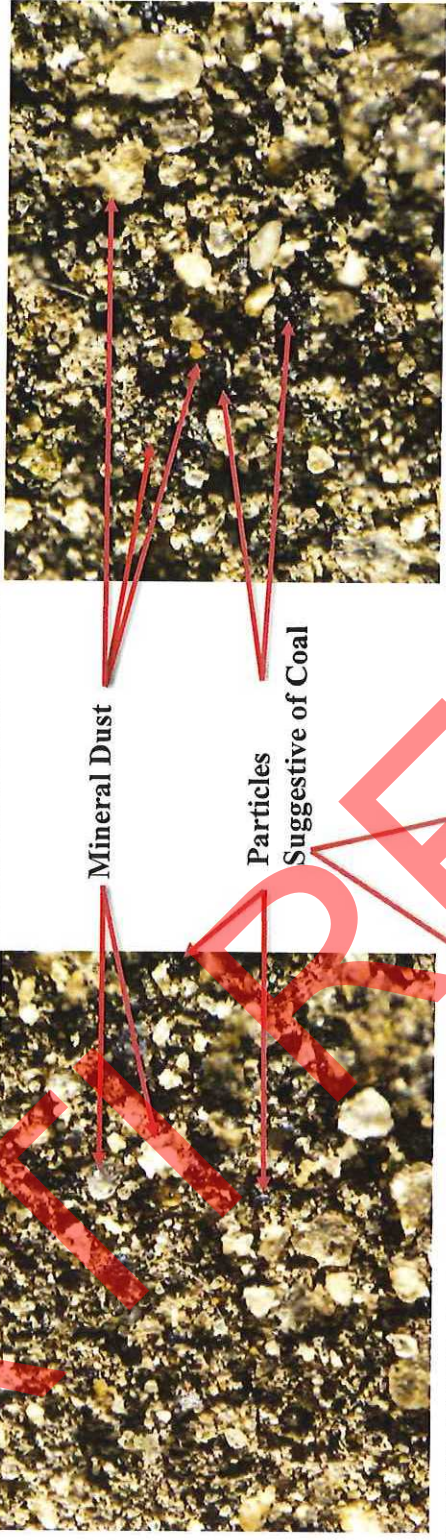
E. CV SHORE, UQMP # 14962. Intermediate Fraction.

Images D, E and F display coarse and fine grained mineral dust particles from translucent, white, yellow to brown. Black glossy angular particles suggestive of coal are scattered throughout all fractions of the deposit. Plant debris is noted in the fine fraction (F) and several filamentous algae particles are also present.

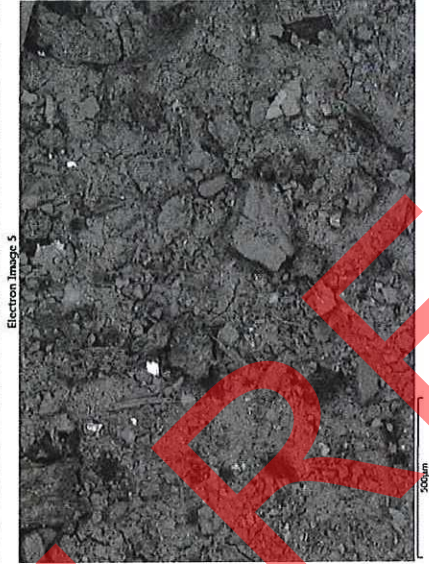
PM1. EHP S.V CV WETLANDS, UQMP # 14961, Sludge as Received Fraction. An SEM/BSE image of an overall area of the As Received Fraction, selected for SEM/EDS analysis.

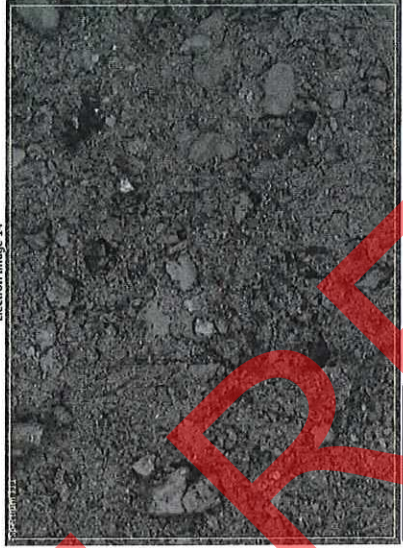
PM4, CV SHORE, UQMP # 14962. Sludge as Received Fraction. An SEM/BSE image of an overall area of the As Received Fraction, selected for SEM/EDS analysis.

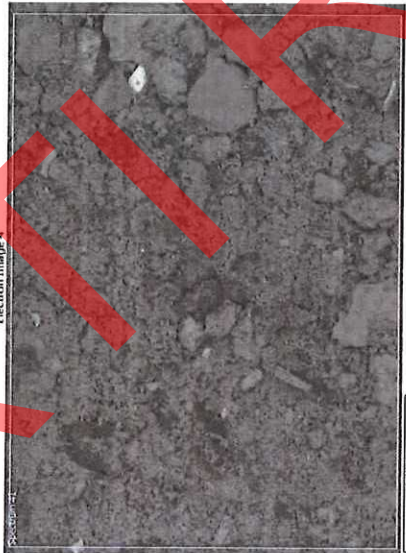
PM5. CV SHORE, UQMP # 14962. An SEM/BSE image of an overall area of the Intermediate Fraction, selected for SEM/EDS analysis.

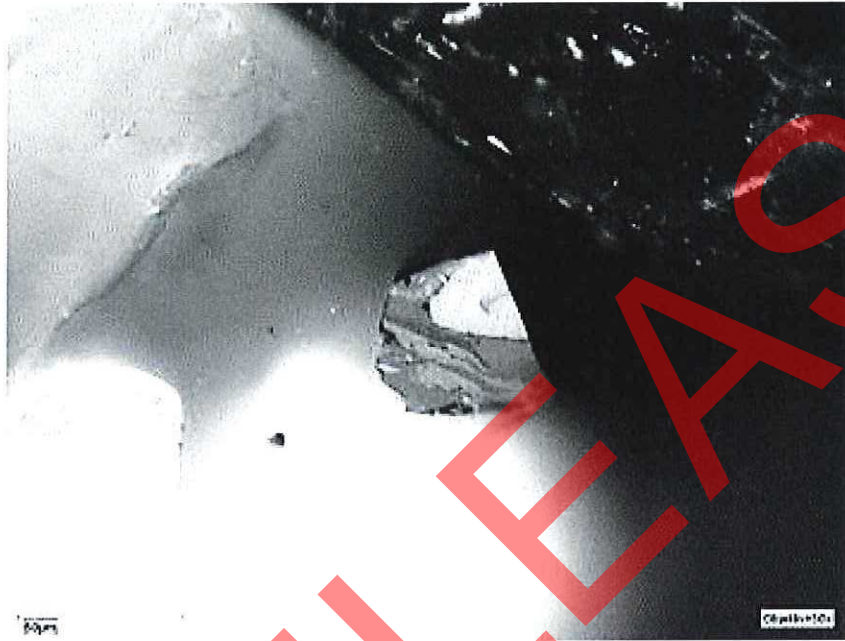
Figure 1: A coal dust particle, areas of Vitrinite and Inertinite are clearly visible; 50x objective, oil immersion, reflected white light.

There was a low volume of coal observed in all three samples. The coal in the samples could clearly be identified by the presence of macerals (macerals are the components that make up a coal) as can be seen in Figure 1. The samples were devoid of organic material. Magnetite was predominant in some of the samples and so has been classified separately from other minerals.

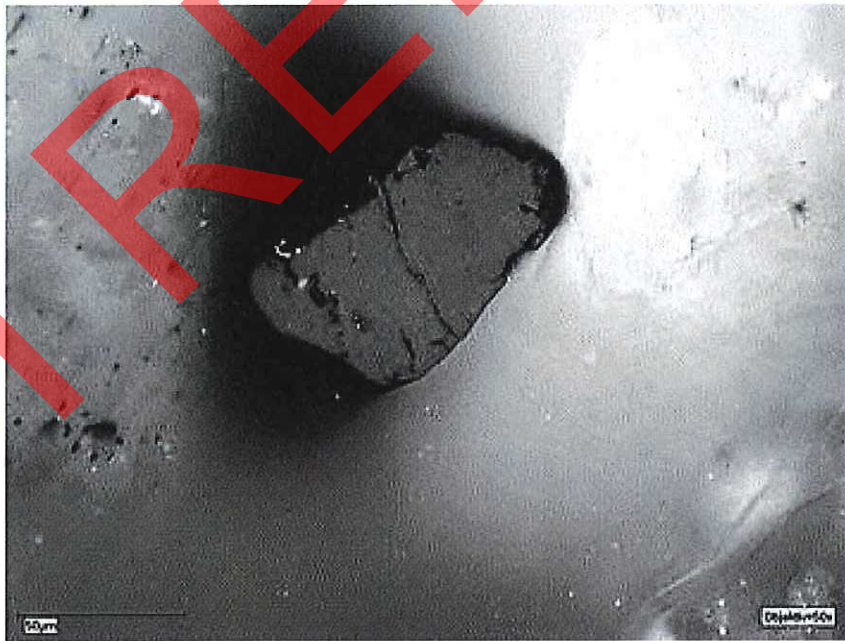
Figure 2: A Vitrinite dominant coal grain; 50x objective, oil immersion, reflected white light.

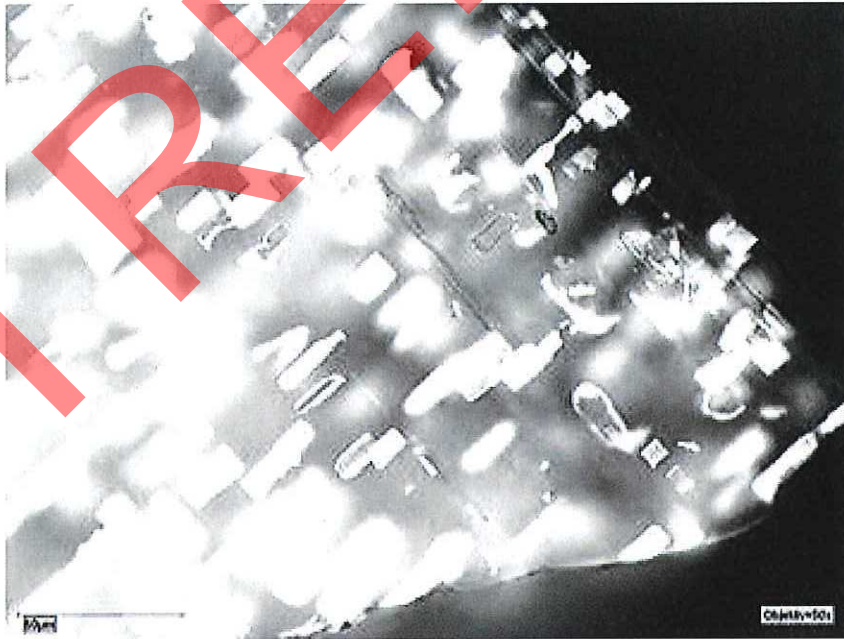
Figure 4: Mineral matter; 50x objective, oil immersion, reflected white light.

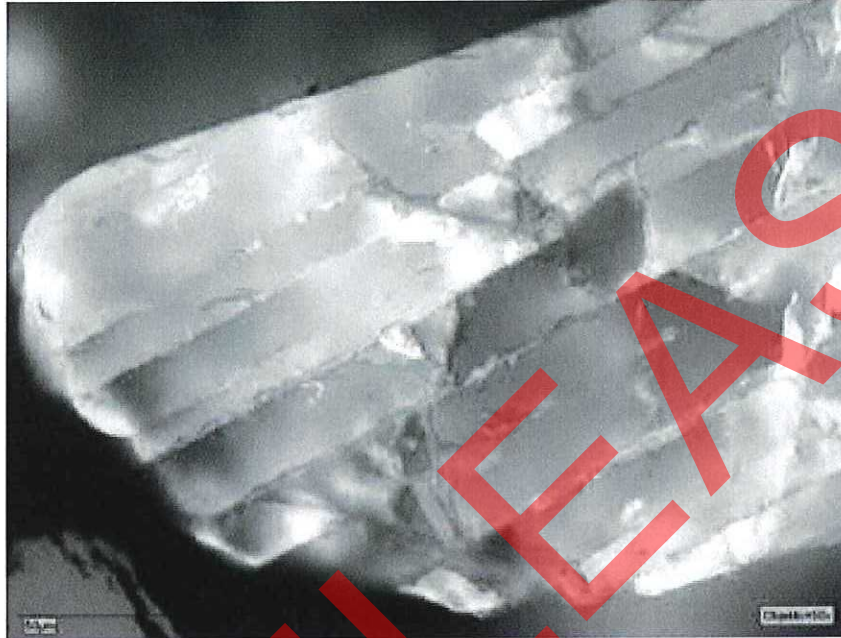
Figure 5: Mineral matter; 50x objective, oil immersion, reflected white light.

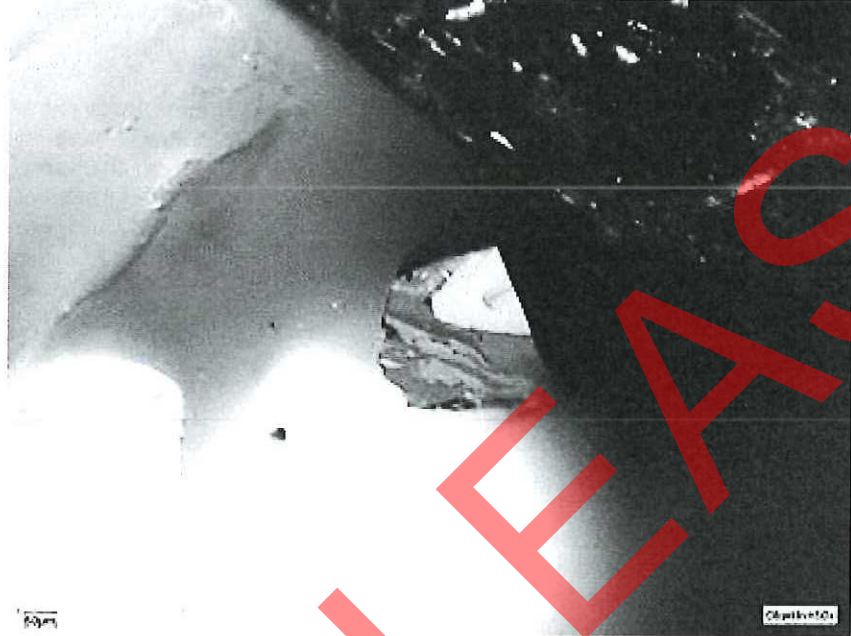
Figure 1: A coal dust particle, areas of Vitrinite and Inertinite are clearly visible; 50x objective, oil immersion, reflected white light.

There was a low volume of coal observed in all three samples. The coal in the samples could clearly be identified by the presence of macerals (macerals are the components that make up a coal) as can be seen in Figure 1. The samples were devoid of organic material. Magnetite was predominant in some of the samples and so has been classified separately from other minerals.

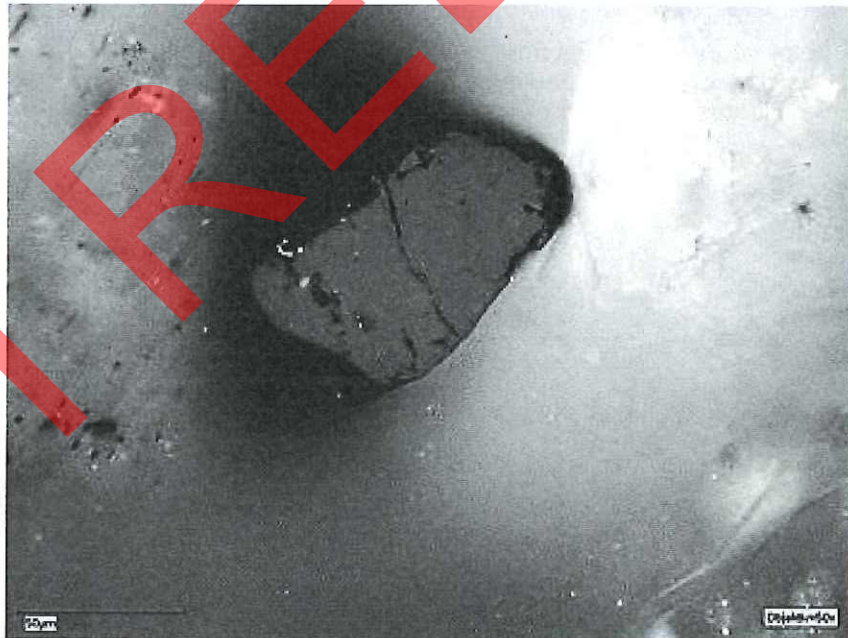
Figure 2: A Vitrinite dominant coal grain; 50x objective, oil immersion, reflected white light.

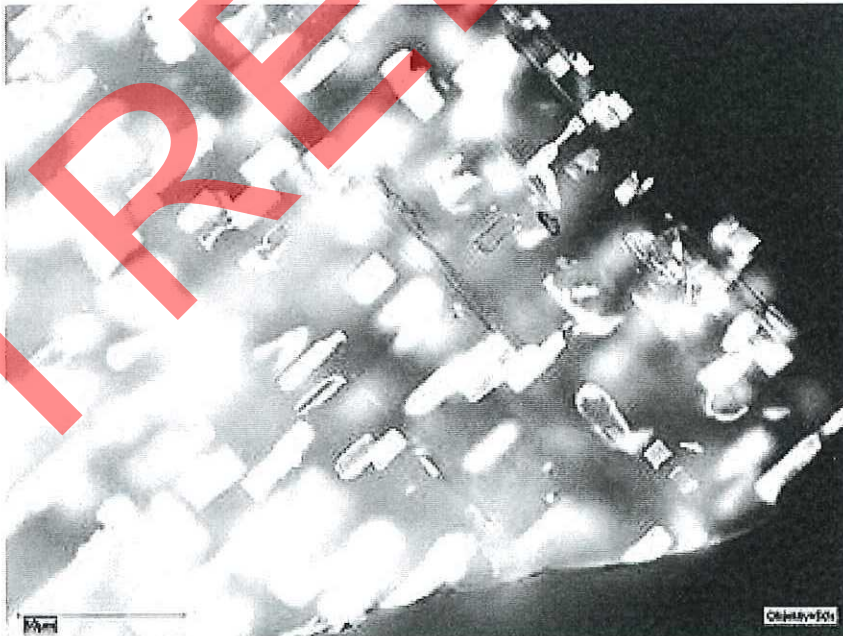
Figure 4: Mineral matter; 50x objective, oil immersion, reflected white light.

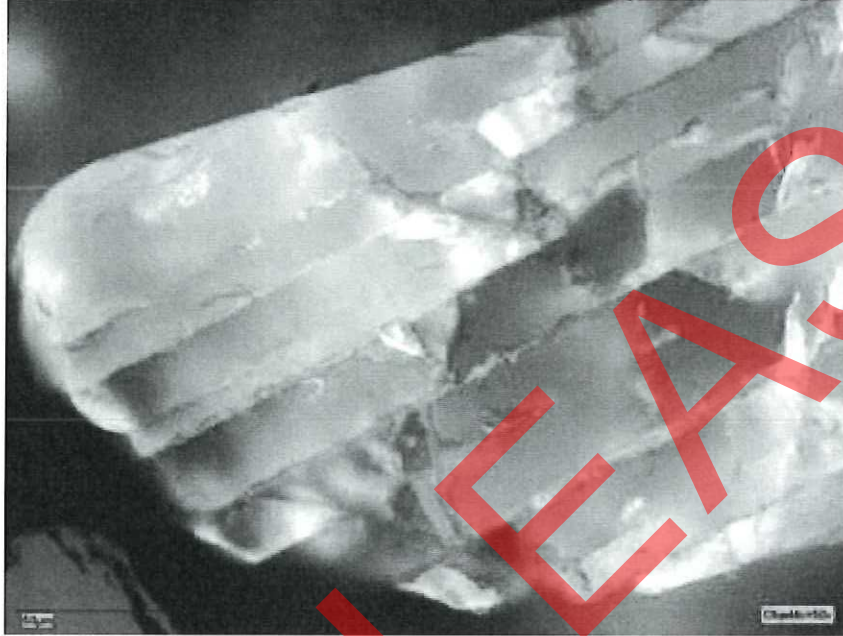
Figure 5: Mineral matter; 50x objective, oil immersion, reflected white light.

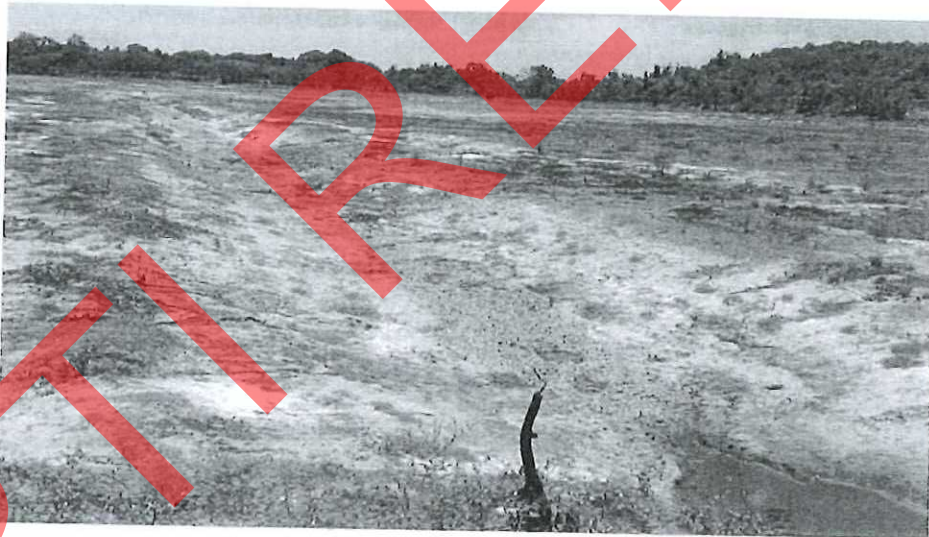
Pond Status Prior to 2nd March 2016

Based on this information, APB predicts site received approximately 501mm of rain during the weather event. This value is consistent with site's historical rainfall data and pond water levels observed in the Secondary Settlement Pond (SSP) and what was observed after the recent Tropical Cyclone and electrical storm. For example, between 2nd and 6th March 2016, 208.8mm of rain was received on site and entered a previously empty SSP. This volume of rain filled the SSP to between one third to half full. Please note the SSP was also empty prior to TC Debbie.

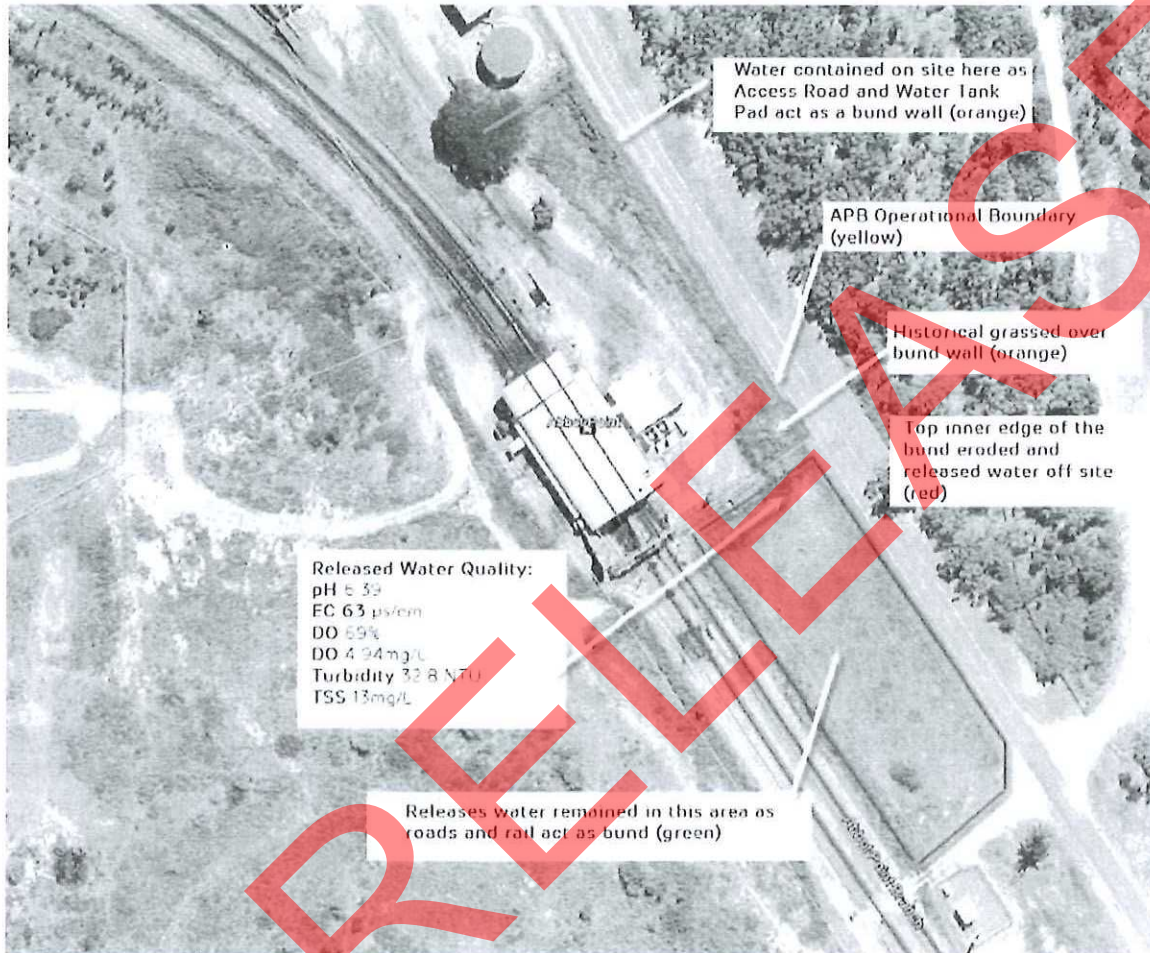
Location of Potential Exceedence at Inloading in Relation to APB Boundary.

The water quality that was released implies it comprised heavily of rain water as the pH was neutral and the EC was very low. TSS and turbidity results also indicate the water was very clear however coal fines were evident and would have contributed to the turbidity and TSS value. The area in which the water was received to is a naturally low lying area which fills with rain water naturally. The vegetation in this area consists of grass that has been introduced and is mowed to maintain visibility to vehicles using the access road. Based on the *in situ* data, laboratory analysis, incident inspections and an assessment of the environmental values of this area, APB is confident no environmental harm was caused by this release.

Related Release	Action at time	Further Action
W2	Samples collected	Nib wall to be designed and installed between sump and boundary (approx. 600mm high) to prevent future releases from this location.
	Inspection of incident and potential impact	
	Notification to EHP via Pollution Hotline	
Inloading	Samples collected	Once water has evaporated from this area, repair artificial bund and raise height.
	Inspection of incident and potential impact	
	Notification to EHP via Pollution Hotline

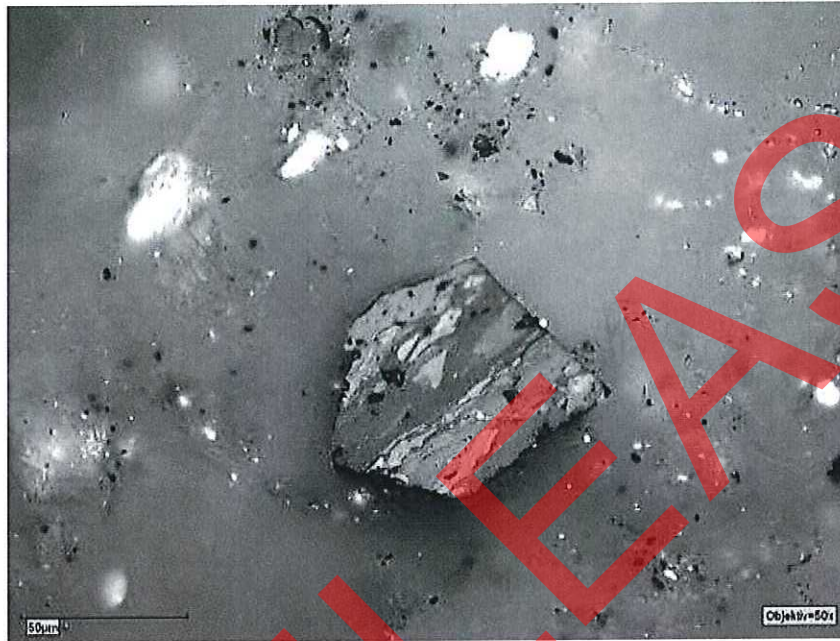
Figure 1: A coal dust particle, areas of Vitrinite and Inertinite are clearly visible; 50x objective, oil immersion, reflected white light.

There was a low volume of coal observed in all three samples. The coal in the samples could clearly be identified by the presence of macerals (macerals are the components that make up a coal) as can be seen in Figure 1. Organic matter observed in the samples seemed to be predominantly decaying plant material.

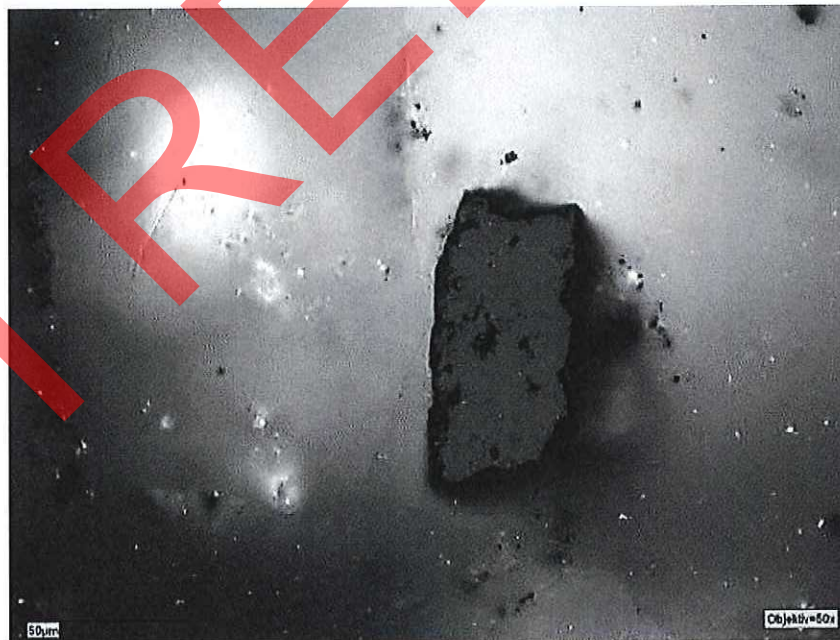
Figure 2: A Vitrinite dominant coal grain; 50x objective, oil immersion, reflected white light.

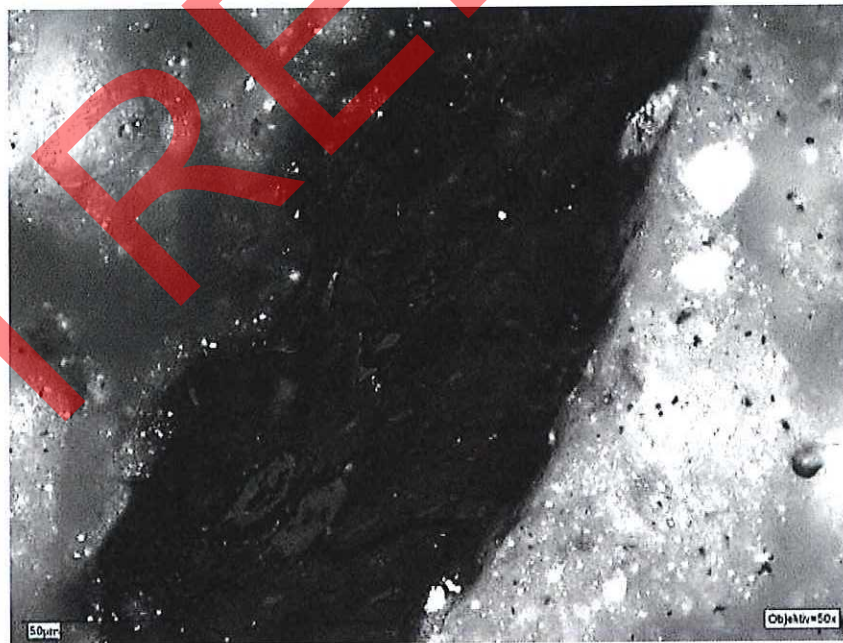
Figure 4: Organic material. Although decayed, some cellular structure is still visible; 50x objective, oil immersion, reflected white light.

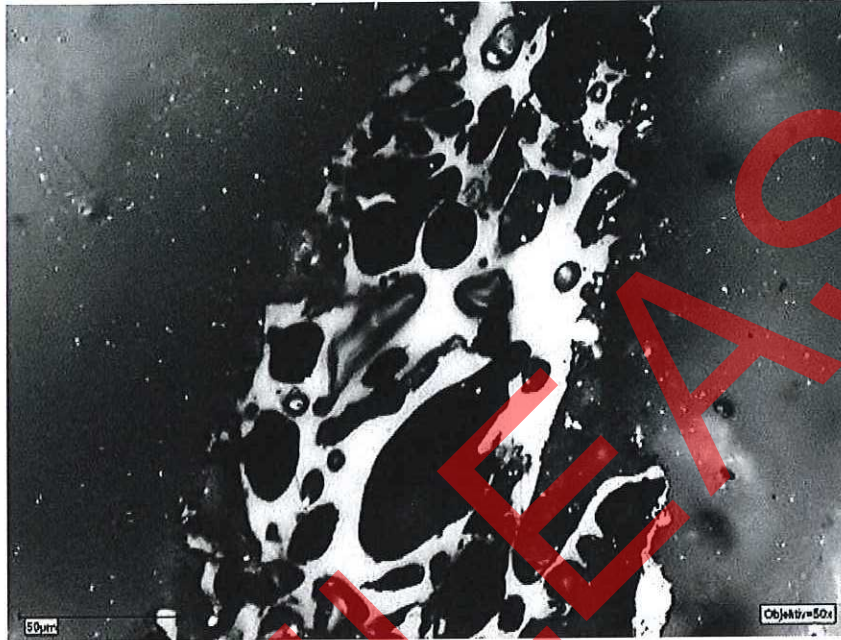
Figure 5: Organic matter; 50x objective; oil immersion, reflected white light.

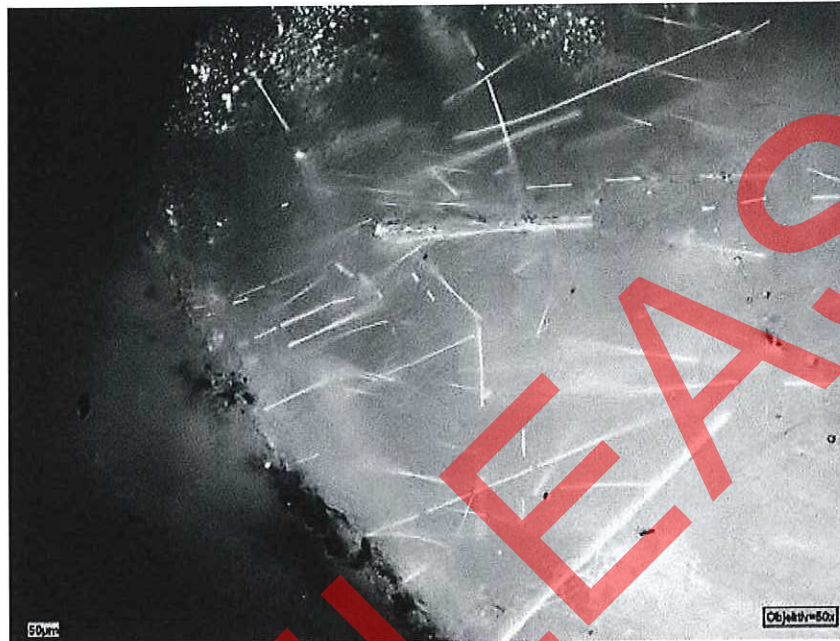
Figure 7: Mineral matter; 50x objective, oil immersion, reflected white light.
