Rear Opening Hand Made Shower Commode Seat

SPINAL INJURIES UNIT

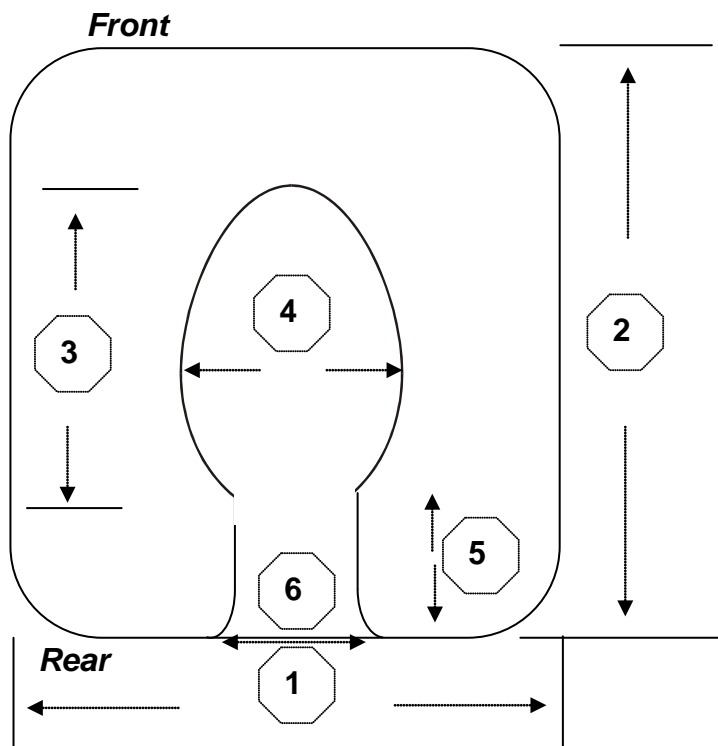
DIMENSIONS*		
1	Width	
2	Depth	
3	Hole Length	
4	Hole Width	
5	Hole Location	
6	Rear Opening

*Measurements have been taken from:
Seat board – underside
Foam – top side
