## Right Side Bite

### Hand Made Shower Commode Seat

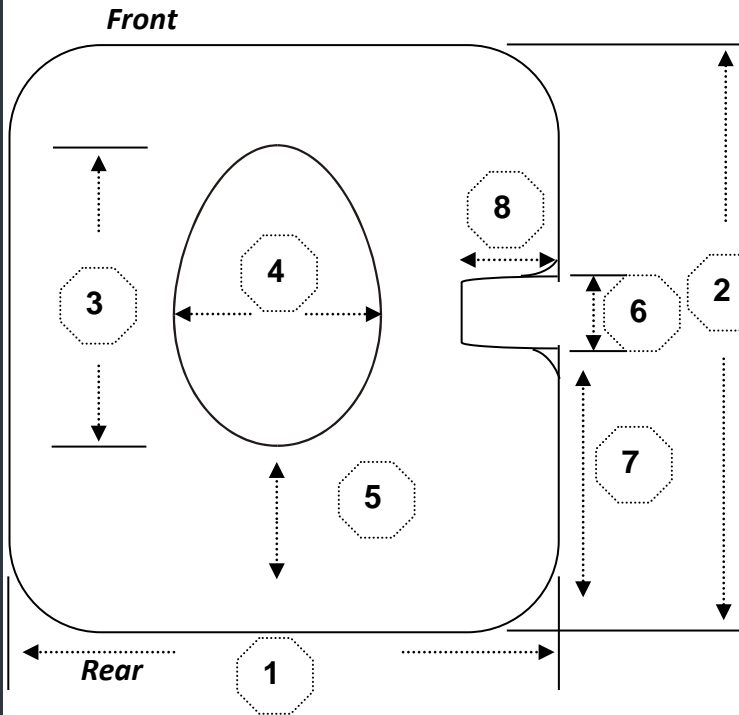
DIMENSIONS*		
1	Width	
2	Depth	
3	Hole Length	
4	Hole Width	
5	Hole Location	
6	R side Bite	
7	Bite Location	
8	Bite depth

\*Measurements have been taken from:  
Seat board – underside  
Foam – top side
